## PROJECT 10073 RECORD

# PHOTO ANALYSIS REPORT

NR 67-64

SUBJECT UNIDENTIFIED FLYING OBJECT

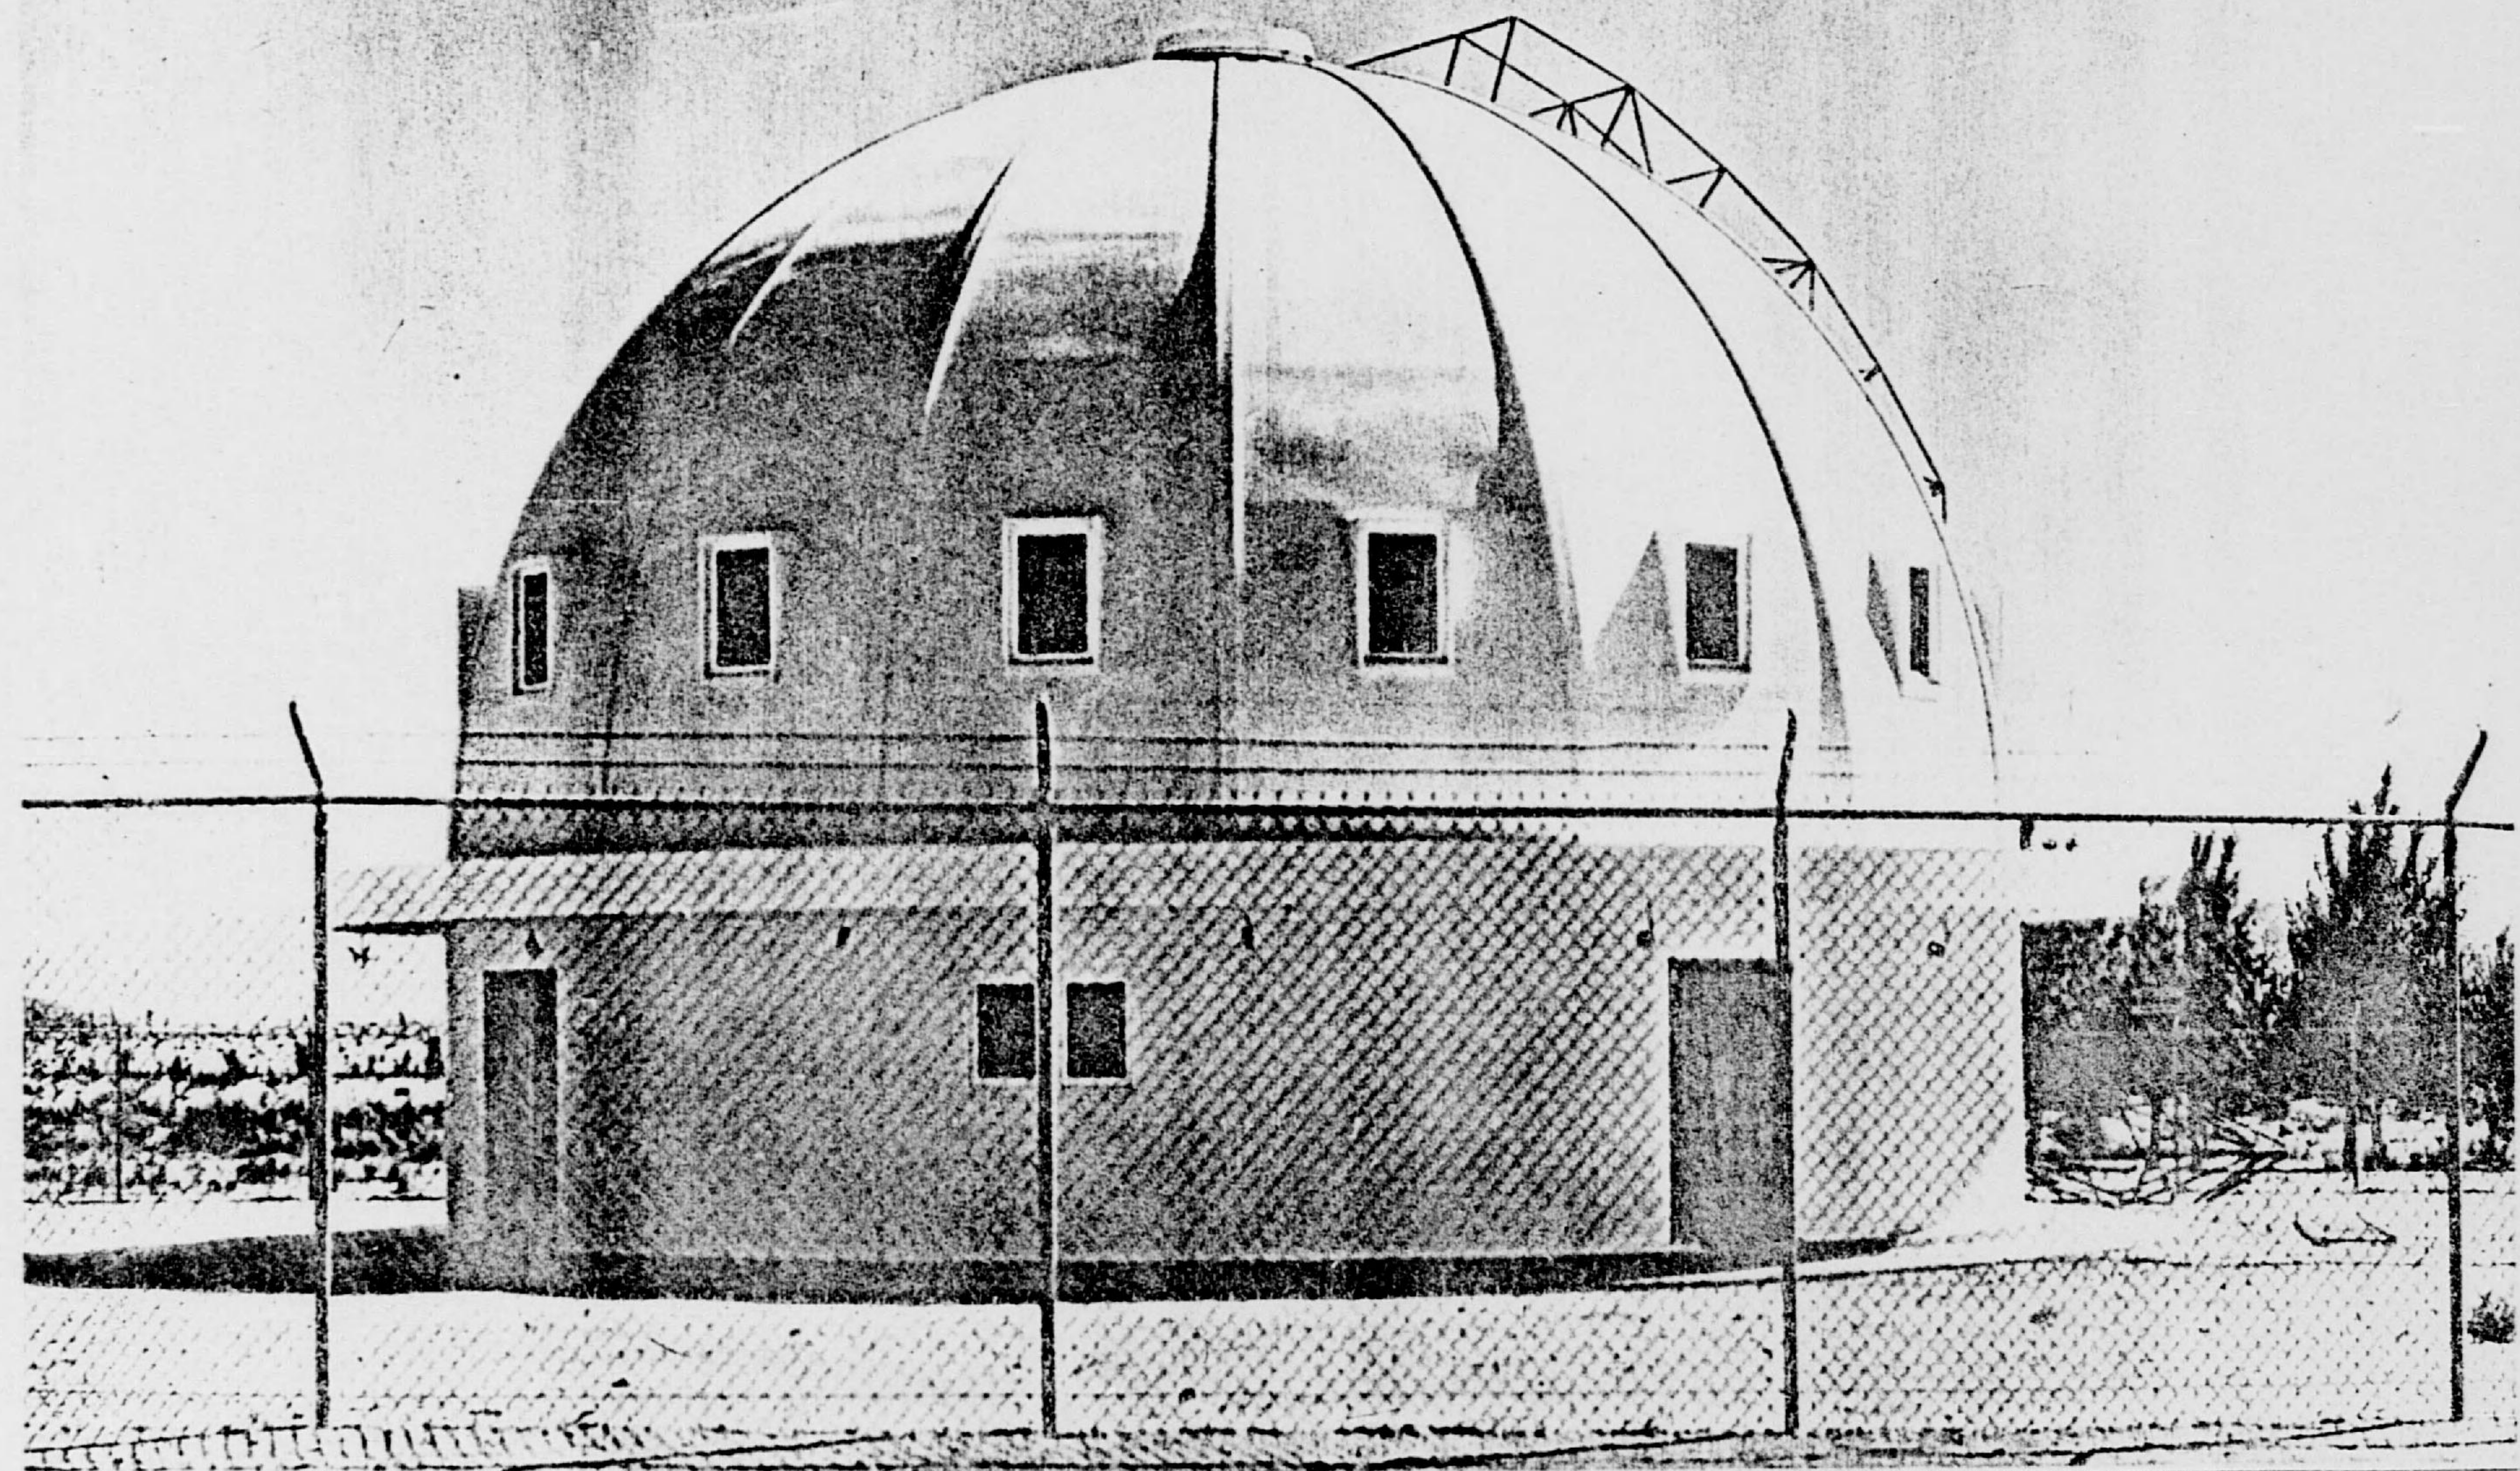
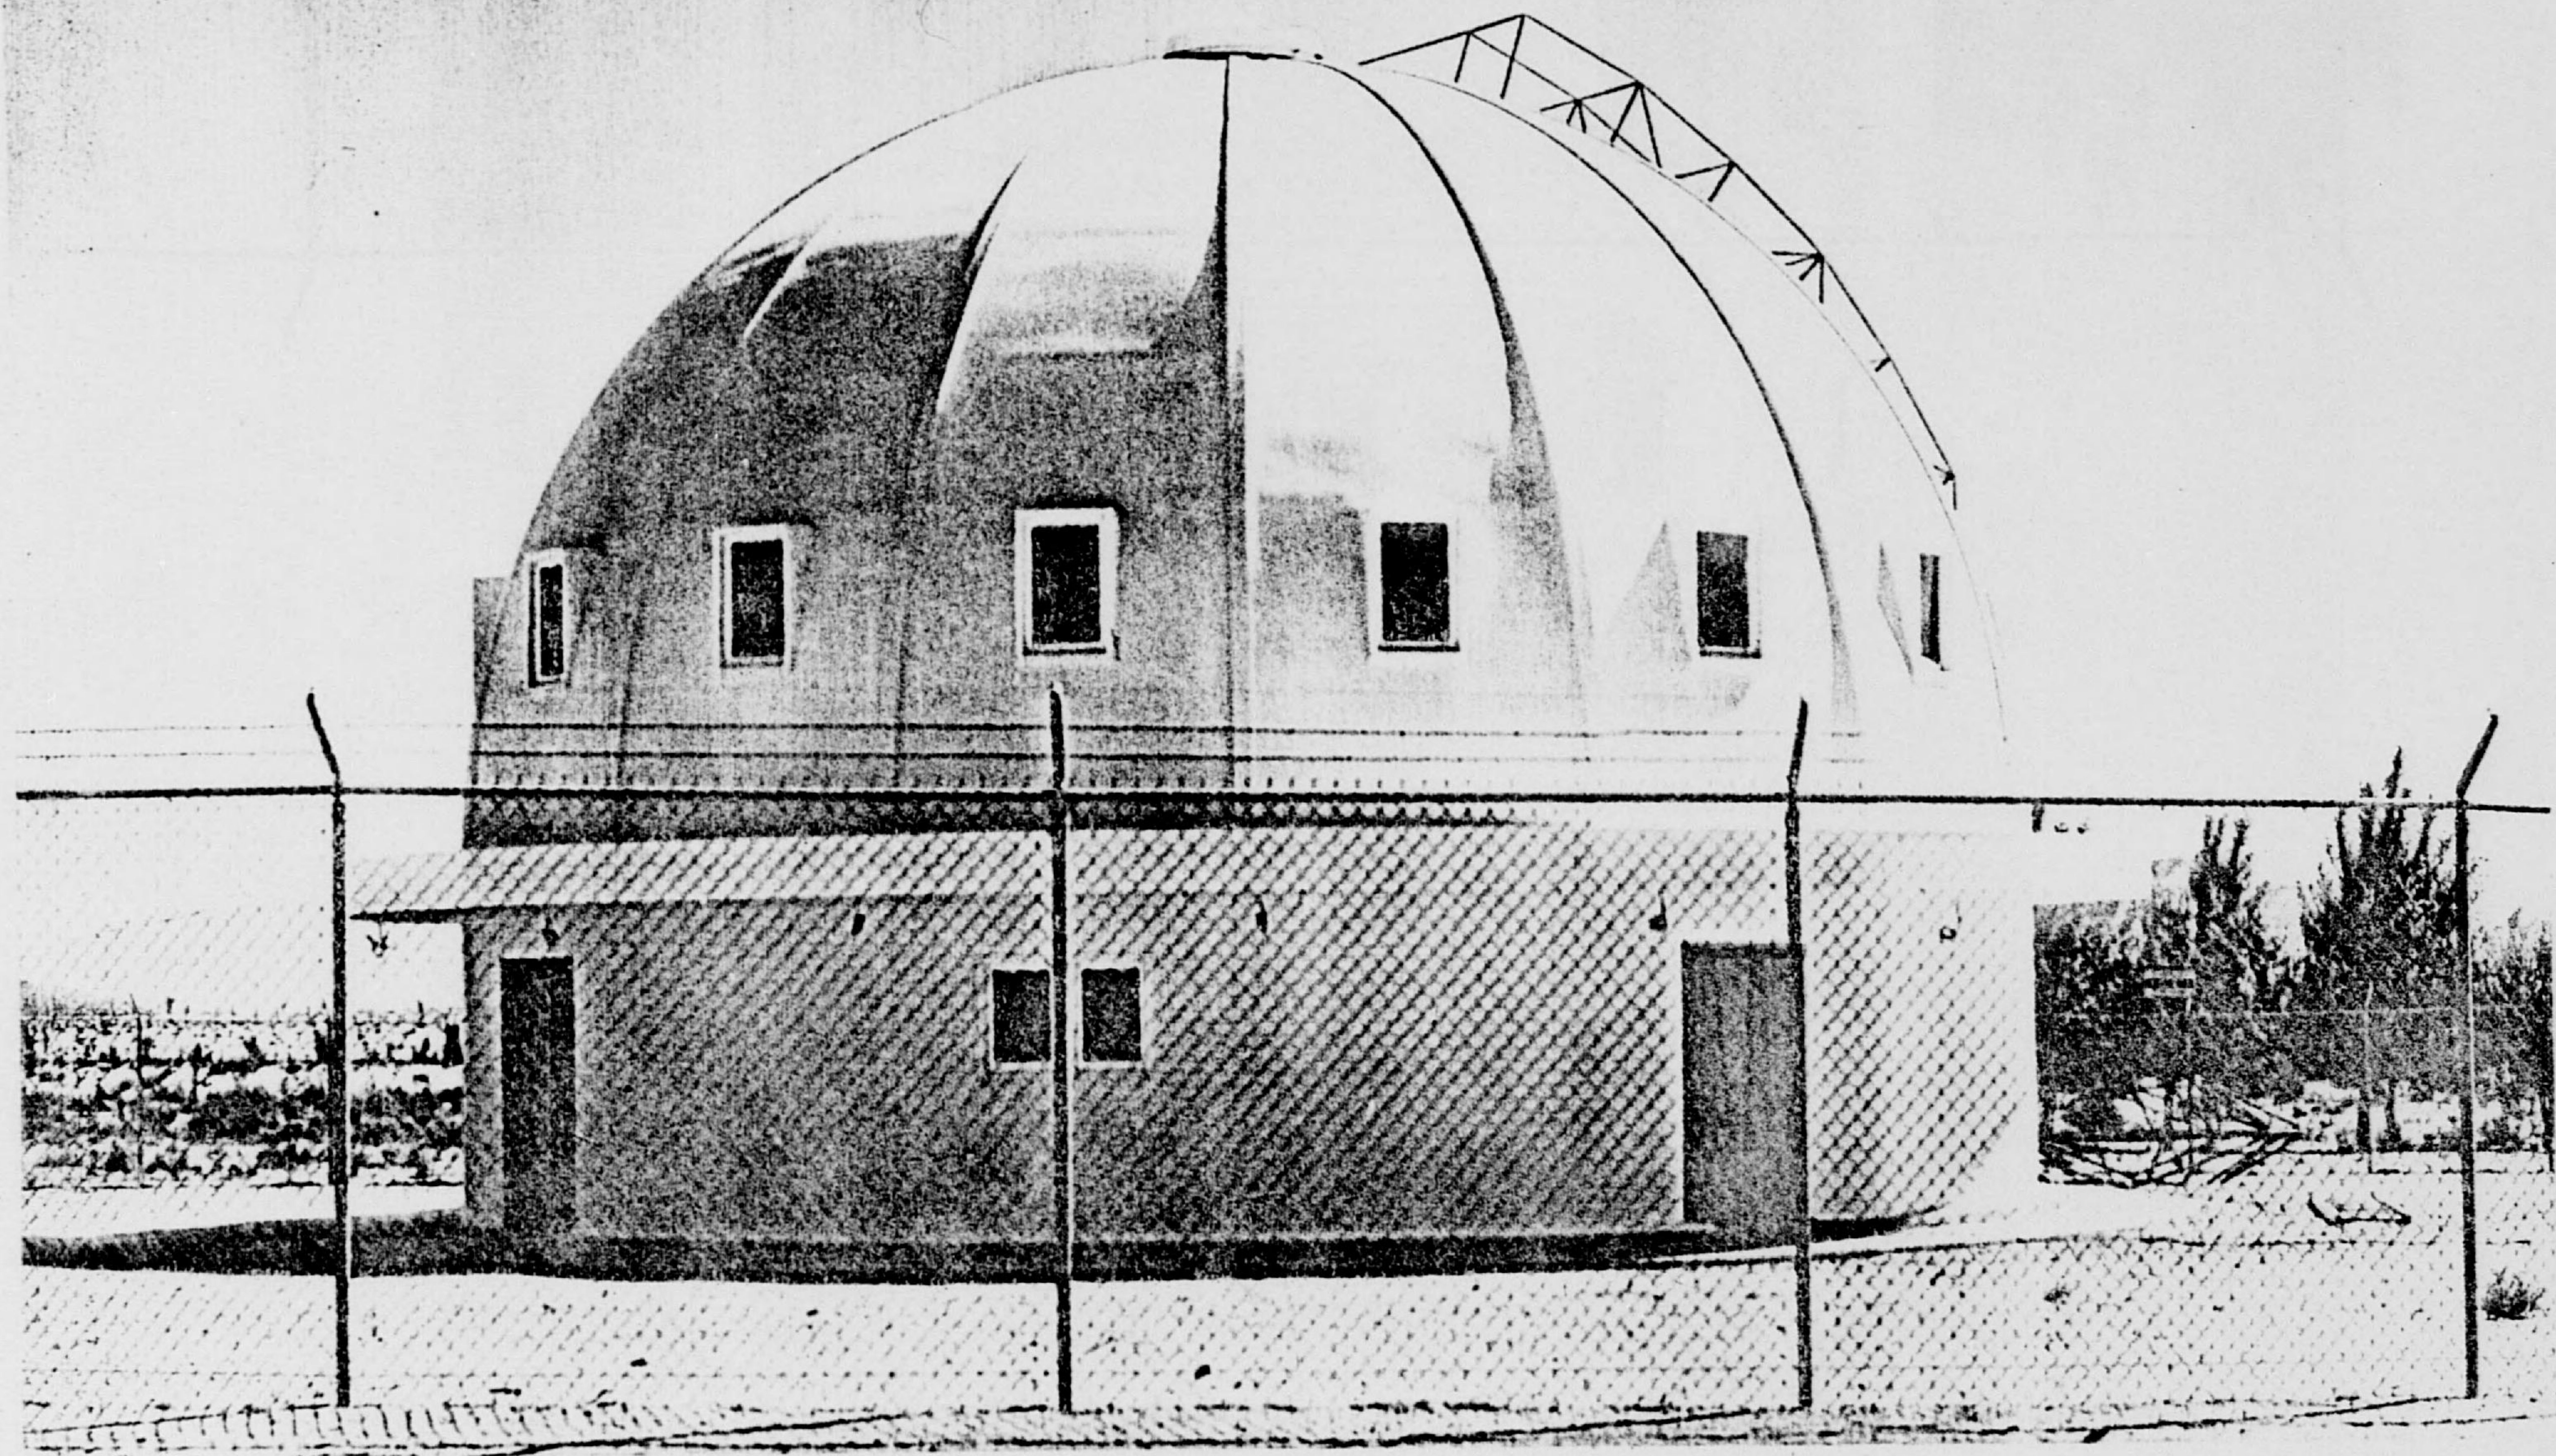
| 5. LENGTH OF OBSERVATION<br>N/A | 11. BRIEF SUMMARY AND ANALYSIS<br>The observer at no time saw the object. The image was on the roll of film when he developed it. |
| 7. COURSE<br>N/A | COMMENTS: Photo experts stated that the image could possible be the result of a film processing defect, such as a bubble in the developer or a light reflection. |

2. ANALYSIS: The object cannot be definitely identified. There is the possibility that it could be a film processing defect, such as a bubble in the developer, or a light reflection. An analysis of the original negative could possibly reveal new information which cannot be gleaned from the paper prints that have been made available.

As soon as I inspected the film after its development, I noticed a donut-shaped object in the sky above the building's dome. It appeared to be an undeveloped spot surrounded by a clear area. Naturally, the clear area appears as a black ring in the finished print.

My first reaction was to conclude that somehow the developer had failed to reach that spot and that the result was a flaw on the negative. Perhaps, I thought, that portion of the film had been touching another spot on the same roll as it lay coiled in the development tank. But no corresponding flaw appears anywhere else on that roll. The tank used, incidentally, is a 16 oz. Nikor, designed to hold one roll of 120 film.

- (1) If the white spot is the result of lack of development, what is the explanation for the clear ring (clear on the negative, that is) surrounding it?
- (2) Instead of being clearly defined around the edges, as might be expected of a spot caused by chemicals, this spot is fuzzy around the edges, as might be expected in the photograph of an object in motion.
- (3) I have taken and developed thousands of pictures, and this is the first time I have seen anything like this on any of them. It is certainly an astounding coincidence that the one picture in which it does appear was taken in an area in which flying saucer sightings have been so often reported and that it appears, not superimposed on the building or on the ground, but in the sky, where one would expect to see a flying saucer.
